**JONES LAKE DAM**

**OREGON COUNTY, MISSOURI**

**MO 31486**

**PHASE 1 INSPECTION REPORT  
NATIONAL DAM SAFETY PROGRAM**

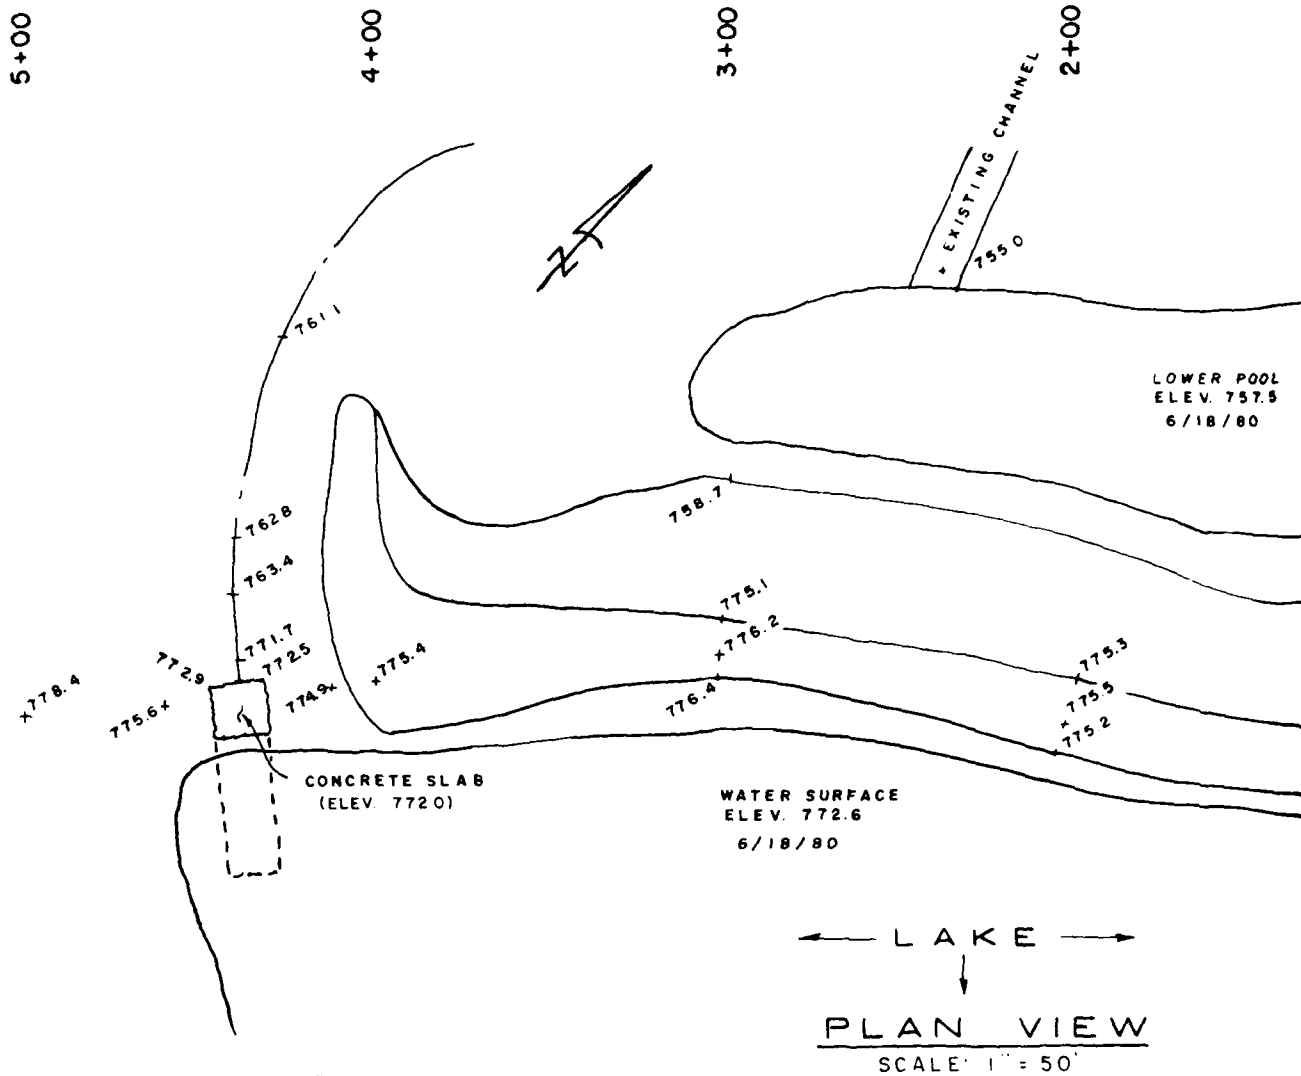
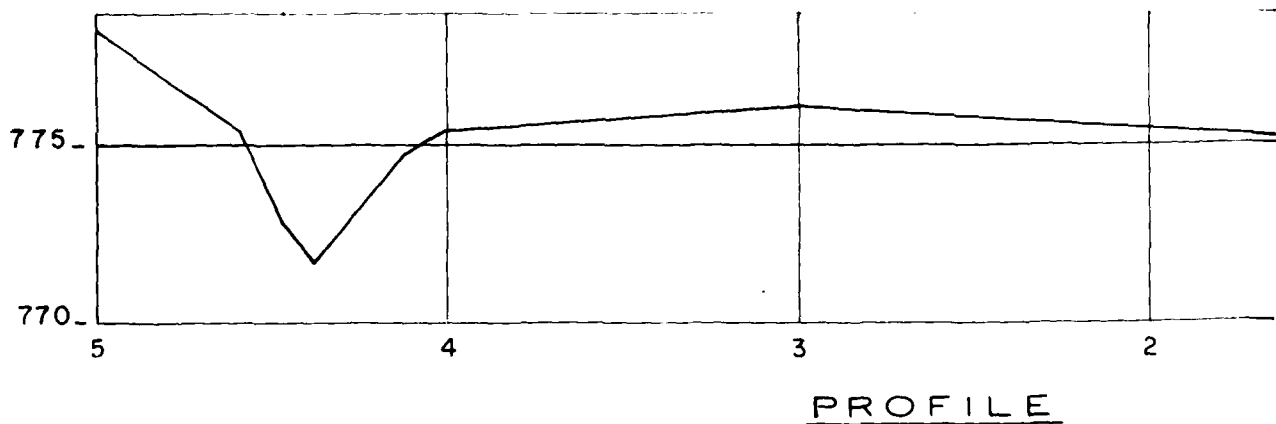
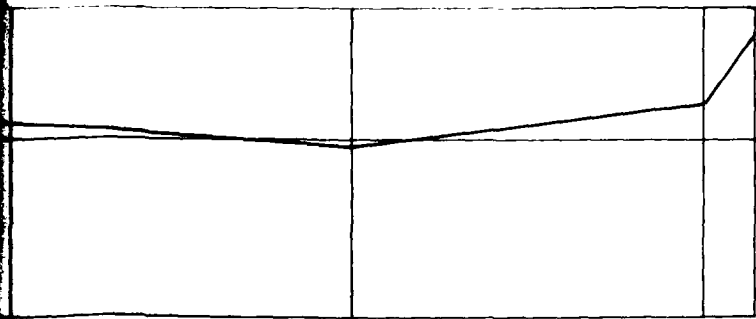
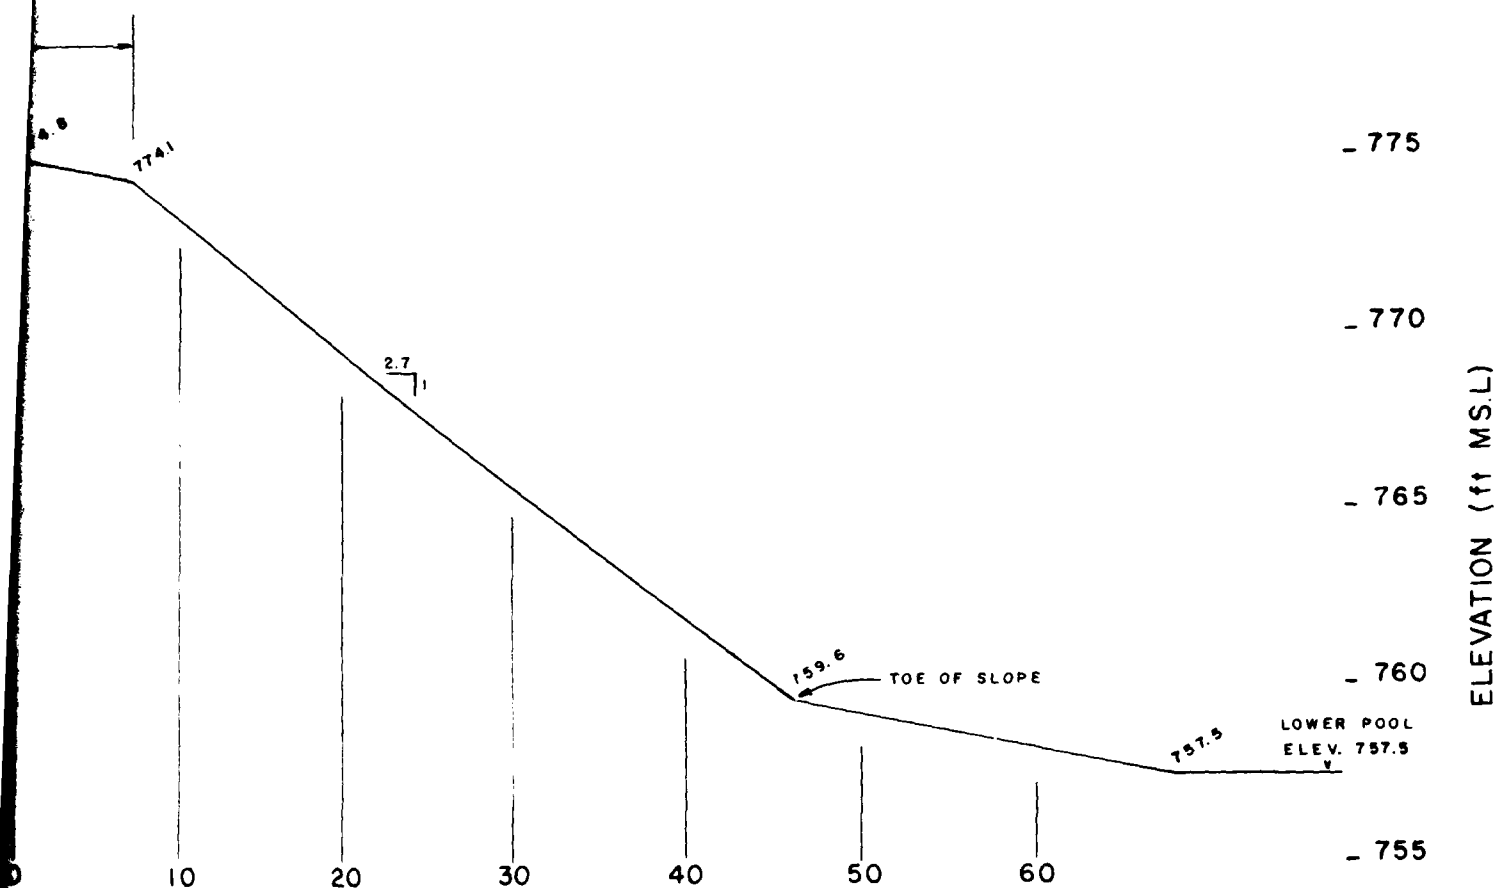
The vertical alignment of the crest seemed good. The dam was built on a curve (concave upstream), and no surface cracking or unusual movement was obvious. The presence of a pond at the downstream toe precluded inspecting this area for stability and additional seepage problems. The owner reported that the pond was there before the dam was built. Sheet 5 of Appendix A presents a plan sketch of the dam showing observed features.
